## CITY OF WASHINGTON, ILLINOIS

**Agenda Item:** Smoke Testing Report and Path Forward

**City of Washington**  
**2022 Smoke Testing Program**  
**REL Project #22-R0435**

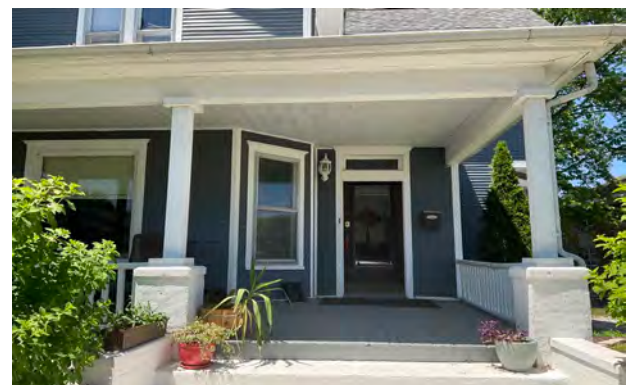
**Building Interior:** Forty-eight (48) houses were found to have smoke inside the building, when residents informed the testing crew of the occurrence. In some cases, these could indicate an improperly connected sump pump to the system, however they could also indicate problems with the plumbing configuration, such as floor drains or sinks without a p-trap. For these

cases, we generally recommend that a follow-up building inspection be conducted to get a more thorough inspection of the internal plumbing and to better determine the exact nature of the issue at each location.

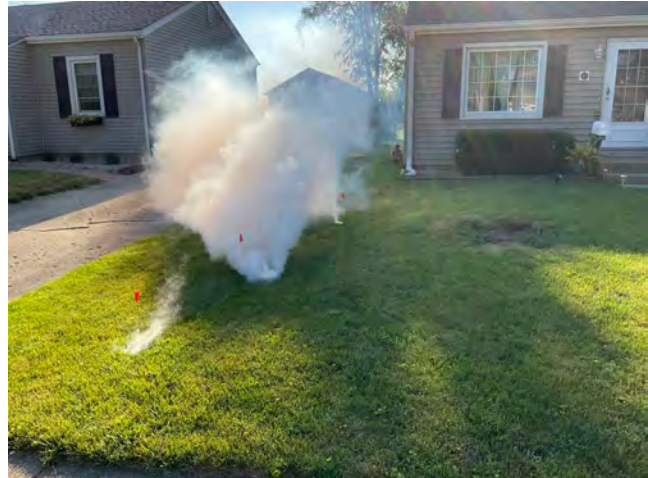
**Cleanouts:** One hundred and eighty (180) cleanouts were found to be emitting smoke. Each cleanout that smoked had a drainage area specific for that location. While cleanouts are appropriate connections to sanitary sewers and facilitate maintenance, they must be sealed to prevent inflow from entering the sanitary sewer system. In most cases, homeowners can effectively seal these cleanouts by purchasing new covers. In other cases, it may be necessary to

excavate around the stack or the vertical riser portion of the cleanout pipe that extends from the ground surface down to the service lateral pipe leading to the mainline sewer. The estimated repair efficiency for cleanout cover repairs is 80%.

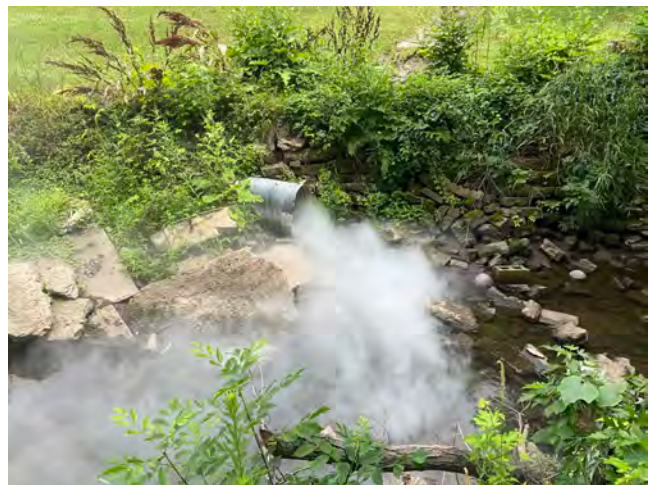
**Creek/Stream:** One (1) Creek/Stream defect was located. In this type of defect, a pipe in the side of the creek bed was found to be smoking upon inspection. This defect type can potentially contribute a significant portion of I&I, as the water moving through the creek bed has access to enter and overload the sanitary sewer system. We recommend that further inspections on the sources of the smoking pipes be performed, and appropriate corresponding actions taken. The estimated repair efficiency of for this defect is not yet known and can be determined after further investigations are completed.

- 5. Wet Weather Investigations for Defects Near Creeks** – It is undetermined if the smoking pipes found near creeks are an inflow source where I&I is entering the sanitary sewer system during wet weather, or if these are bypasses that allow excess wet weather I&I to leave the sanitary sewer system at connection points to the creeks. To better understand these locations that smoked, follow up wet weather investigations are needed to determine the details of the piping configuration and flow

conditions at these locations. CCTV is also recommended in these areas to determine entry and exit points for these smoking culvert pipes adjacent to creeks.

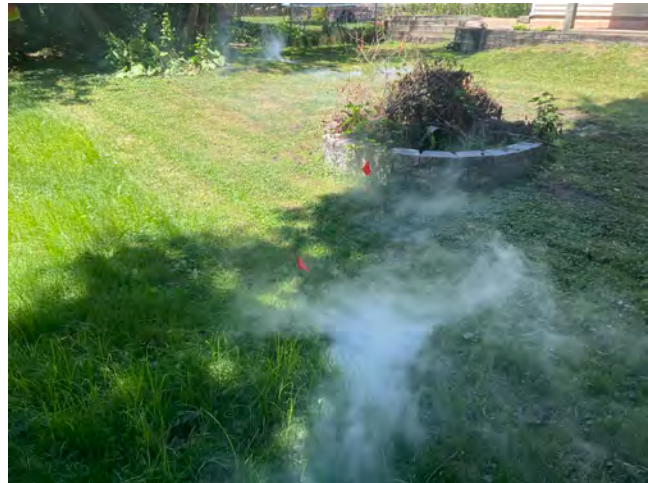
**Main Line:** Sixty-nine (69) main line pipe defects were found. Like leaking lateral defects, the drainage areas of these defects are also estimated at 100 square feet per each location identified smoking. Main line sewer defects can be repaired by replacing the piping, doing mainline sewer cured-in-place pipelining (CIPP), or doing spot repairs. Before these repairs are conducted, it is recommended to perform CCTV of each section of mainline sewer that was identified smoking. The estimated repair efficiency for main line replacement is 85%.

- 3. CCTV Smoking Sewer Mains & Cured-In-Place Pipelining (CIPP) Repairs** – Numerous sewer mains were identified as smoking during this project. At a minimum, those identified with smoke defects are recommended to be cleaned and televised and then repaired with cured-in-place pipelining to provide structural repairs and to lessen the effects of I&I entering at those locations. Cured-in-place pipelining may need to be coupled with point repairs, service lateral grouting and or service lateral T-lining to effectively seal up mainlines from identified I&I sources. The extent of the additional repairs needed can be further evaluated after CCTV inspection is done. The cost of cured-in-place pipelining alone for mainline deficiencies found is estimated at \$335,526.

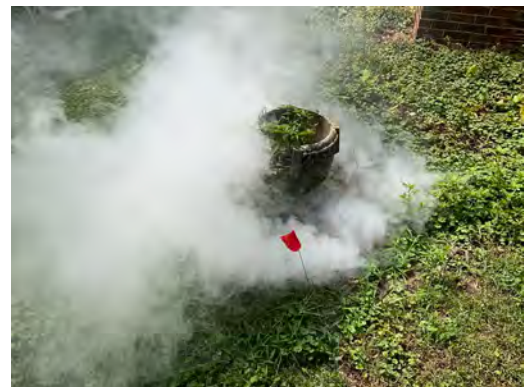
**Other:** Thirty-six (36) defects were classified as “other” defects when they were found during smoke testing. Some of these defects include cisterns, gas meter caps, electrical boxes, and many more. In most cases, the cause of the sanitary cross connection to these defects needs to be further inspected. The contributions to I&I can be attributed to the drainage areas of the surrounding environment, or the size/capacity of the cistern. The estimated repair efficiencies for these “other” defects will vary on a case-to-case basis.

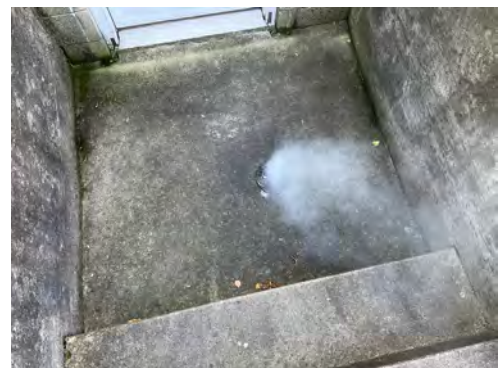
**Stairwell Drain:** Fifteen (15) stairwell drains were found to be connected to the sanitary system. The drainage area for these defects can be calculated from the total area of the stairs and stairwell and the surface where the drain is located. These defects can be very difficult and expensive to remove from the system and are often the last to be considered for enforcement actions or for sequenced private sector source disconnection programs. The estimated repair efficiency for stairwell drains is 80%.
