CITY OF WASHINGTON, ILLINOIS

Committee of the Whole Agenda Communication

Agenda Item: Smoke Testing Report

City of Washington
2022 Smoke Testing Program
REL Project #22-R0435

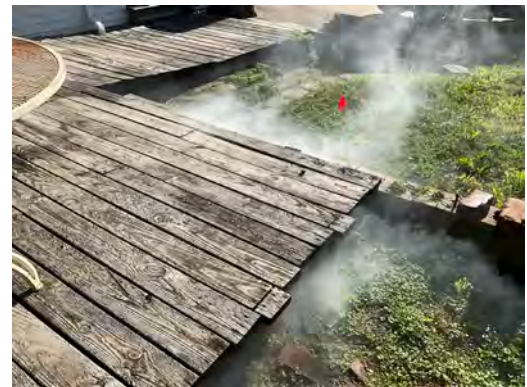
Area Drain: Seven (7) area drains were found emitting smoke during testing. The correct use of an area drain is for the transfer of rainfall or surface stormwater away from the lawn, patio or other location to the street or storm sewer where it can drain to creeks or waterways. In these cases, the smoking area drains were connected to the sanitary sewer redirecting the stormwater away from the property but contributing to the overloading of the sanitary sewer with excess stormwater. Depending on the size of the area, these drains can be significant contributors of I&I. The estimated repair efficiency for fixing area drains is 80%.

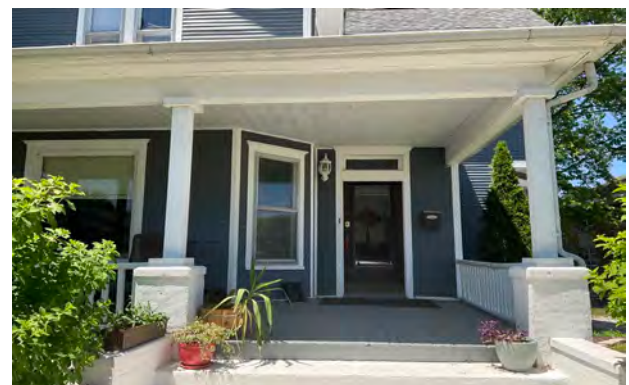
Building Interior: Forty-eight (48) houses were found to have smoke inside the building, when residents informed the testing crew of the occurrence. In some cases, these could indicate an improperly connected sump pump to the system, however they could also indicate problems with the plumbing configuration, such as floor drains or sinks without a p-trap. For these

cases, we generally recommend that a follow-up building inspection be conducted to get a more thorough inspection of the internal plumbing and to better determine the exact nature of the issue at each location.

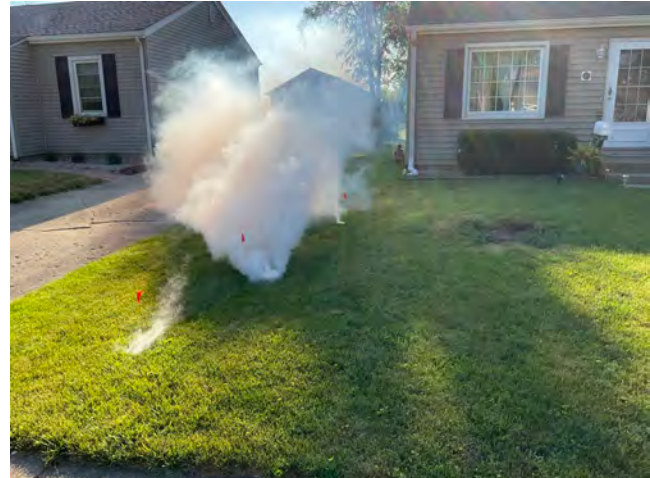
Cleanouts: One hundred and eighty (180) cleanouts were found to be emitting smoke. Each cleanout that smoked had a drainage area specific for that location. While cleanouts are appropriate connections to sanitary sewers and facilitate maintenance, they must be sealed to prevent inflow from entering the sanitary sewer system. In most cases, homeowners can effectively seal these cleanouts by purchasing new covers. In other cases, it may be necessary to

excavate around the stack or the vertical riser portion of the cleanout pipe that extends from the ground surface down to the service lateral pipe leading to the mainline sewer. The estimated repair efficiency for cleanout cover repairs is 80%.

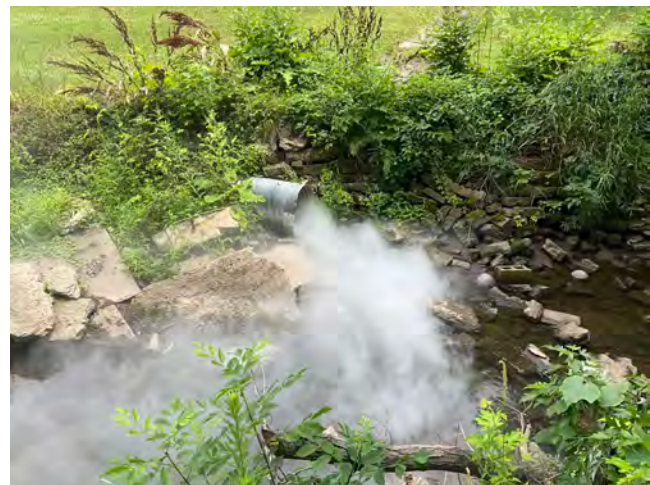
Creek/Stream: One (1) Creek/Stream defect was located. In this type of defect, a pipe in the side of the creek bed was found to be smoking upon inspection. This defect type can potentially contribute a significant portion of I&I, as the water moving through the creek bed has access to enter and overload the sanitary sewer system. We recommend that further inspections on the sources of the smoking pipes be performed, and appropriate corresponding actions taken. The estimated repair efficiency of for this defect is not yet known and can be determined after further investigations are completed.

5. **Wet Weather Investigations for Defects Near Creeks** – It is undetermined if the smoking pipes found near creeks are an inflow source where I&I is entering the sanitary sewer system during wet weather, or if these are bypasses that allow excess wet weather I&I to leave the sanitary sewer system at connection points to the creeks. To better understand these locations that smoked, follow up wet weather investigations are needed to determine the details of the piping configuration and flow

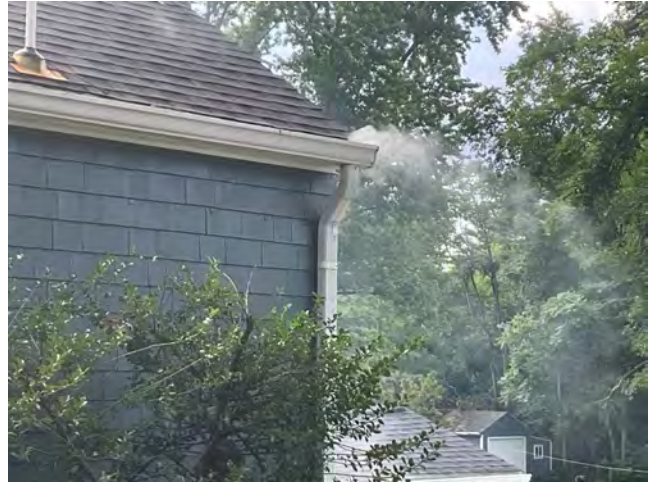
Downspouts: Ninety-seven (97) structures were found with downspouts emitting smoke during testing. These downspouts can contribute large areas of drainage to the sanitary sewer system, resulting in significant contributions of I&I. The recommended repair for these defects is to properly disconnect the downspouts by digging them up and then plugging and capping them with a wing plug and cement mortar cap thereby disconnecting these pipe connections that lead into the sanitary sewer. The estimated repair efficiency for disconnecting downspouts is 80%.

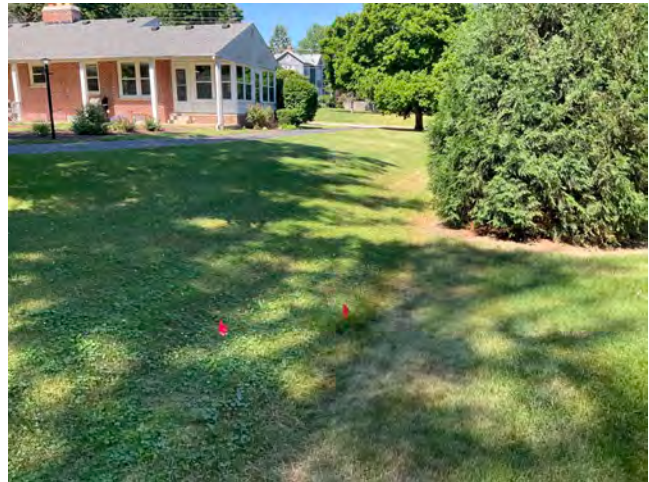
Drainage Ditch: One (1) drainage ditch was found smoking in the project area. Drainage ditches usually run along property lines and are used to collect and redirect overland stormwater flows from rainfall. Since they are typically made in permeable ground surface conditions and can have relatively large drainage areas, they can be large sources of I&I. It is recommended that this drainage ditch is dyed water flooded in conjunction with closed-circuit televising (CCTV) to further pinpoint and quantify the point of sanitary sewer leakage and connection to this ditch. The estimated repair efficiency for disconnecting drainage ditches by repairing sanitary sewer pipes is 90%.

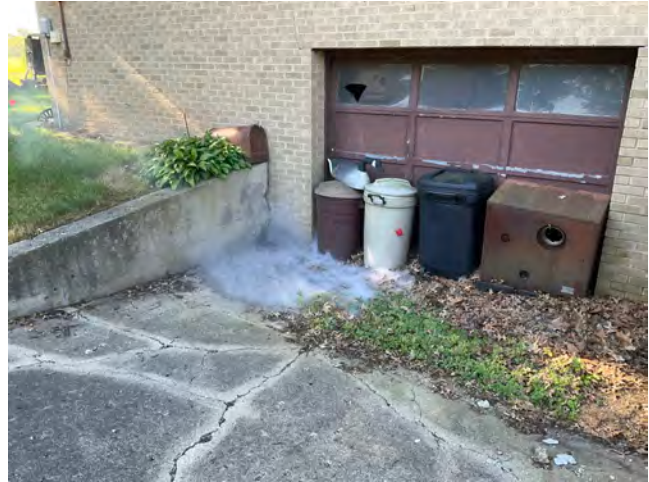
Driveway Drain: Three (3) locations were found with a driveway drain connected to the sanitary sewer. Driveway drains can collect large amounts of surface rainwater and are usually located at the sloped end of the driveway area. These are recommended to be disconnected from the sanitary sewer system as they are large contributors of I&I. The estimated repair efficiency of fixing driveway drains is 80%.

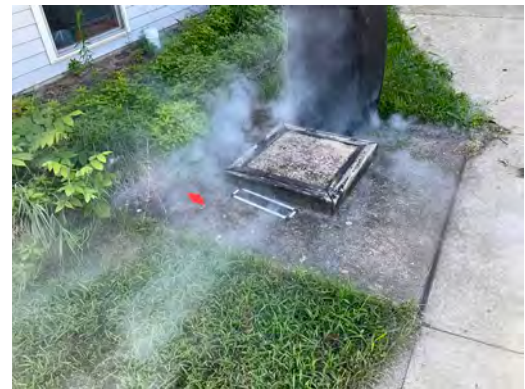
External Sump Pumps: Six (6) locations were found with an external sump pump connection to the sanitary sewer. In these instances, there was either an internal storm sump pump discharge hose connected to a nearby cleanout, or they were fully external sump pump basins that were observed smoking. Sump pumps can be large contributors of I&I with newer pumps having the pumping capacity of rates up to 20+ gallons per minute (gpm). The estimated repair efficiency for disconnection of sump pumps is 75%.

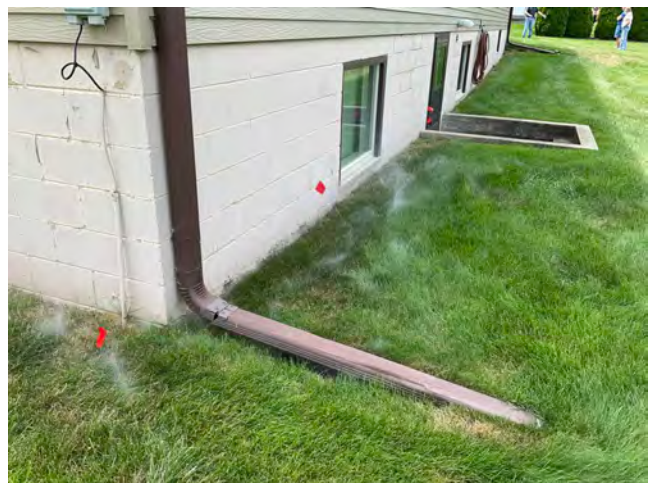
Foundation Drain: Fourteen (14) foundation drains were observed smoking. It is recommended that these be followed up with an internal plumbing inspection and service lateral televising to confirm the connection point of the foundation drain to the sewer and help determine the appropriate means of disconnection. Foundation drains can be large contributors of I&I due to the potential for large drainage areas surrounding the buildings. The estimated repair efficiency for foundation drains is 80%.

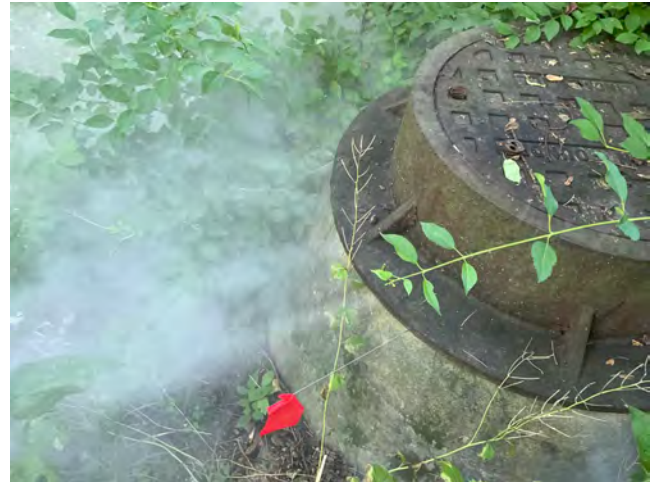
Frame Seal: Fifty (50) manholes were found and identified as having a defective or leaking frame seal throughout the testing. These manholes exhibiting smoke from around the base of the manhole frames typically have a frame seal offset from the manhole structure and/or defective adjusting rings which allow I&I through the frame adjustment area. The manhole frame and adjustment rings are recommended to be sealed and adjusted. The estimated repair efficiency for this work is 75%.

- 1. Fix Public Sector Manhole Defects** – To effectively start reducing I&I on the public sector side of the system, it is recommended that the identified manhole cover and frame seal defects be repaired as soon as possible. Replacing pick-hole lids & poor fitting or non-gasketed lids is considered a relatively simple repair for the City. Estimated costs for purchasing replacement covers are approximately \$25,000 for the replacement of one-hundred and one (100) lids that were found to allow I&I into the system. This work can be conducted in-house by City staff or can be bid and included as part of a larger sewer manhole rehabilitation project. The total estimated costs of manhole frame seal defect repairs identified in this project are \$107,500. The overall project estimate for all manhole cover and frame seal repair work identified is approximately \$132,500.

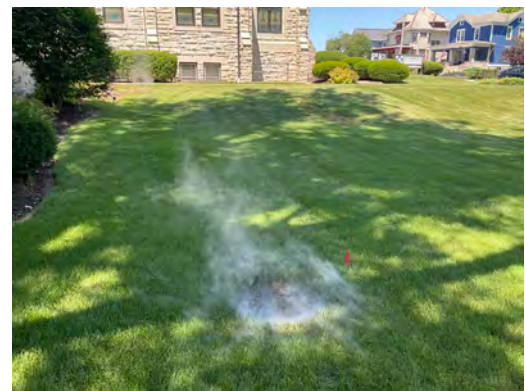
Pick Hole and Gasket Seal Covers: These are I&I defects related to the manhole covers. Forty-eight (48) manholes were identified with a pick hole lid during smoke testing, and these holes allow stormwater to enter the sanitary sewer system. Fifty-two (52) manholes were identified as having a loosely fitting gasket seal cover or poor fitting lid thereby allowing I&I into the system during rainfall events. These manhole lid defects are a relatively simple repair. The City

can purchase and replace these older or poor fitting covers with new ones, thereby reducing I&I into the system. The estimated repair efficiency for this work is 85%.

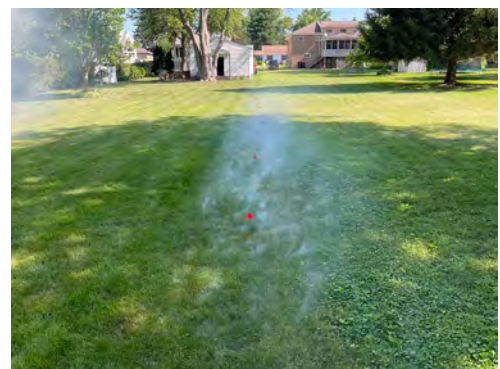
Lateral Defects: One-hundred forty-four (144) service lateral defects were found on 102 service laterals. The drainage areas of these lateral defects are estimated at 100 square feet of drainage per each location smoking. The amount of infiltration contributed by each lateral defect is directly related to the drainage area contributing to the defect. Lateral defects can be repaired by either spot repairs, replacing the lateral or doing service lateral lining. The estimated repair efficiency for lateral replacement is 85%.

7. **Consider a Lateral Televising, Lateral Repair and Foundation Drain Disconnection Program** – This project identified one hundred forty-four (144) lateral defects that were located on one hundred and two (102) distinct properties and fourteen (14) properties that had foundation drains smoking. The City should consider televising the laterals at these properties as part of an overall Lateral Televising, Lateral Repair and Foundation Drain Disconnection Program to assess the internal condition of these pipes. This is also an effective way to identify additional footing tile / foundation drain connections to the private service lateral that can be large contributors of I&I. The estimated cost of televising and lining service laterals identified with defects on this project is \$867,000. The estimated cost for televising and disconnecting the (14) identified foundation drains is \$119,000. This work can be considered after other high priority work is completed.

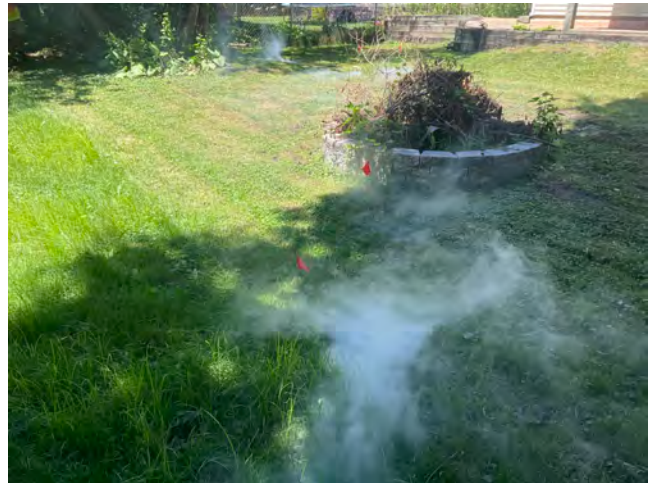
Main Line: Sixty-nine (69) main line pipe defects were found. Like leaking lateral defects, the drainage areas of these defects are also estimated at 100 square feet per each location identified smoking. Main line sewer defects can be repaired by replacing the piping, doing mainline sewer cured-in-place pipelining (CIPP), or doing spot repairs. Before these repairs are conducted, it is recommended to perform CCTV of each section of mainline sewer that was identified smoking. The estimated repair efficiency for main line replacement is 85%.

3. **CCTV Smoking Sewer Mains & Cured-In-Place Pipelining (CIPP) Repairs** – Numerous sewer mains were identified as smoking during this project. At a minimum, those identified with smoke defects are recommended to be cleaned and televised and then repaired with cured-in-place pipelining to provide structural repairs and to lessen the effects of I&I entering at those locations. Cured-in-place pipelining may need to be coupled with point repairs, service lateral grouting and or service lateral T-lining to effectively seal up mainlines from identified I&I sources. The extent of the additional repairs needed can be further evaluated after CCTV inspection is done. The cost of cured-in-place pipelining alone for mainline deficiencies found is estimated at \$335,526.

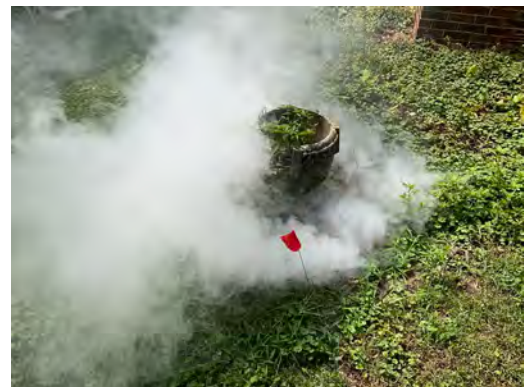
Other: Thirty-six (36) defects were classified as “other” defects when they were found during smoke testing. Some of these defects include cisterns, gas meter caps, electrical boxes, and many more. In most cases, the cause of the sanitary cross connection to these defects needs to be further inspected. The contributions to I&I can be attributed to the drainage areas of the surrounding environment, or the size/capacity of the cistern. The estimated repair efficiencies for these “other” defects will vary on a case-to-case basis.

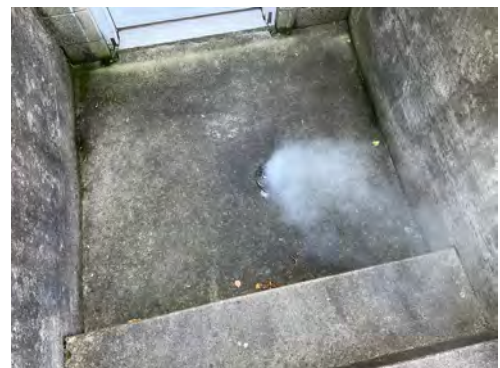
Stairwell Drain: Fifteen (15) stairwell drains were found to be connected to the sanitary system. The drainage area for these defects can be calculated from the total area of the stairs and stairwell and the surface where the drain is located. These defects can be very difficult and expensive to remove from the system and are often the last to be considered for enforcement actions or for sequenced private sector source disconnection programs. The estimated repair efficiency for stairwell drains is 80%.

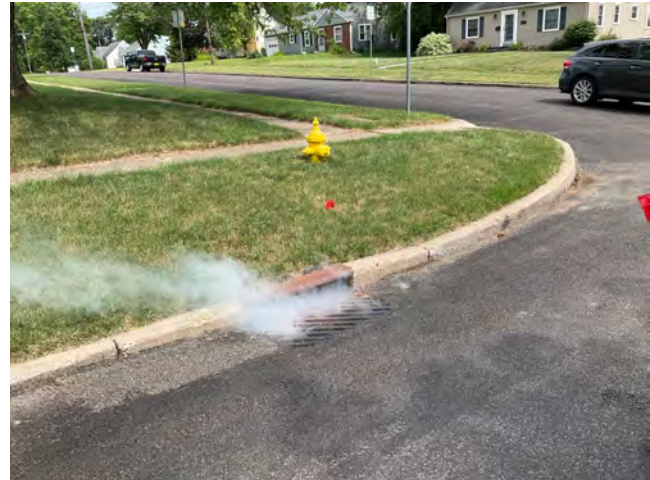
Storm Inlet/CB: Thirty-six (36) storm inlet/catch basin defects were found in the project area. This defect type has the potential to be the largest source of inflow and infiltration out of all possible defects, as it could be the result of direct connections between the sanitary and storm systems or cross-connected sources. The drainage areas for these defects are no less than 500 square feet, with most of them contributing

more than 1,000 square feet of drainage area into the sanitary system. These defects are of high importance to be repaired but recommended first for dyed water flooding, performed in conjunction with CCTV. The estimated repair efficiency for fixing storm inlets is 80% but can vary depending on the other sources contributing that can be identified during follow-up dyed water flooding.

4. **Perform follow-up Dyed Water Testing in Conjunction with CCTV** – This project identified thirty-six storm inlets that are cross-connected and/or directly connected to the sanitary sewer. Prior to their disconnection or repair, the detail of each cross connection is recommended to be further evaluated with dyed water flooding performed in conjunction with CCTV. Additionally, the one Creek/Stream defect and Drainage Ditch defect are also recommended for dyed water flooding. This will enable the City to pinpoint and quantify the specific defect types contributing to these cross-connections, their location and what repairs are needed, i.e., mainline lining, lateral lining, chemical grouting, manhole repairs, etc. The estimated cost for conducting dyed water testing itself is approximately \$57,000. The additional cost for CCTV services is not factored into this cost estimate as sewer televising companies will usually provide an hourly rate to perform this slower production type of work. However, performing the CCTV portion of the work in-house with City staff can eliminate the need to solicit contracted services for CCTV.

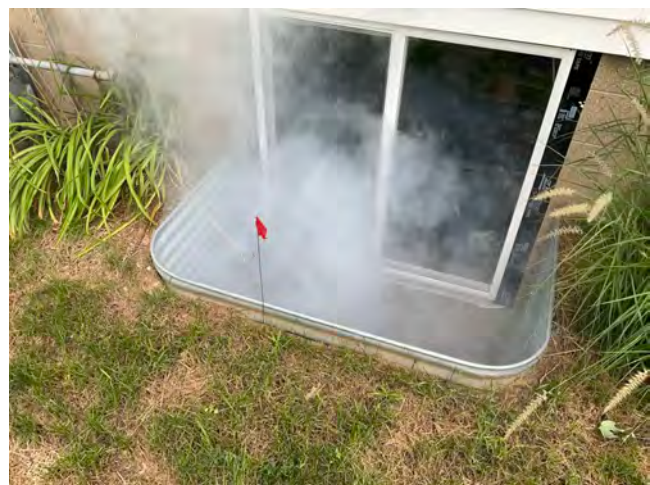
Window Well Drain: Nine (9) window well defects were found during testing. These are not typically large contributors of inflow and infiltration but can be significant depending on the drainage area of the yard pitched toward them. Window wells can also be an indicators of additional sources like foundation drains and/or sump pump connections to the sanitary which can be substantial contributors of I&I. Flows from

window well drains can be estimated by calculating the area of the window well drain as well as any surrounding area that can drain into the well. The estimated repair efficiency of window wells is 80% and usually just involves putting a window well cover over the window well.
