# Memo

TO: Committee of the Whole  
FROM: Ed Andrews, Public Works Director  
SUBJECT: Infrastructure Review  
DATE: January 5, 2018

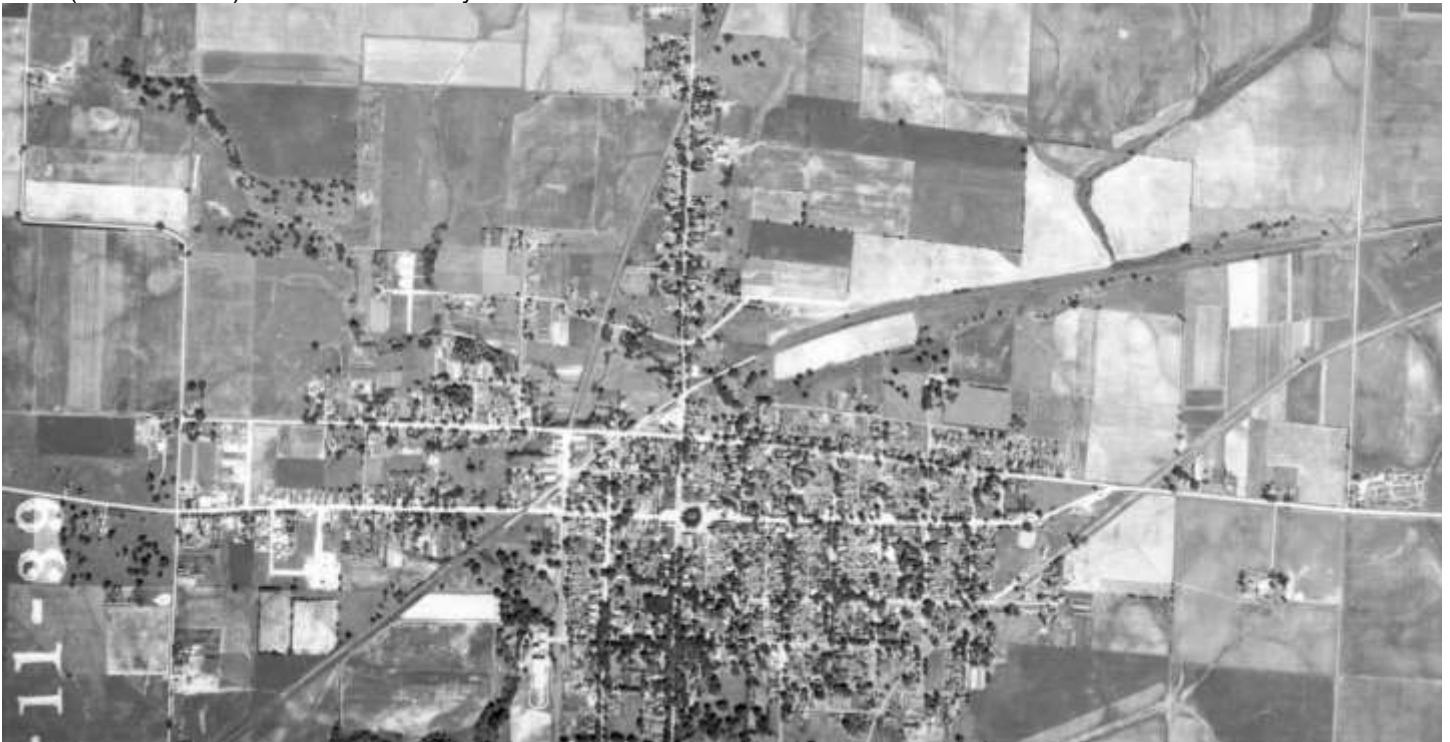
1939 (Source ISGS) – North Half of City

Sanitary – none, private septic and clay wildcat discharge to streams, Unknown  
Water Mains - 4" Cast Iron (CI); estimate 24mi based on current inventory.  
Roadways - Unknown ratio of concrete and brick, asphalt paving industry just starting. est. 24mi  
Storm – concrete and clay pipe, estimate same as current ratio of roads to storm, est. 12 mi  
Bridges – 6 bridges, note: all of these, except Candlewood, have been replaced in the last 50 years.

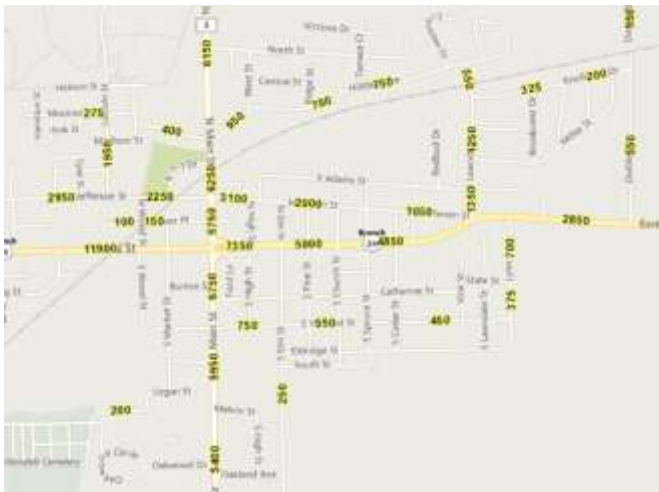
IDOT Average Daily Traffic (ADT)

Traffic volumes and functional classification help to define possible funding sources for rehabilitation of the roadways. Roadways which have Functional Classifications above a Local Road are eligible for Federal Funding. A review of these roadways as mapped by FHWA & IDOT on the east side are:

- E. Holland St = 3,829LF, CRS = 7.0, approx. ADT = 600
- Lynn St = 1,282LF, CRS = 6.0, approx. ADT = 550
- Hilldale Av = 3,580LF, CRS = 5.0, approx. ADT = 500
- N. Lawndale Av = 1,998LF, CRS = 4.5, approx. ADT = 1040

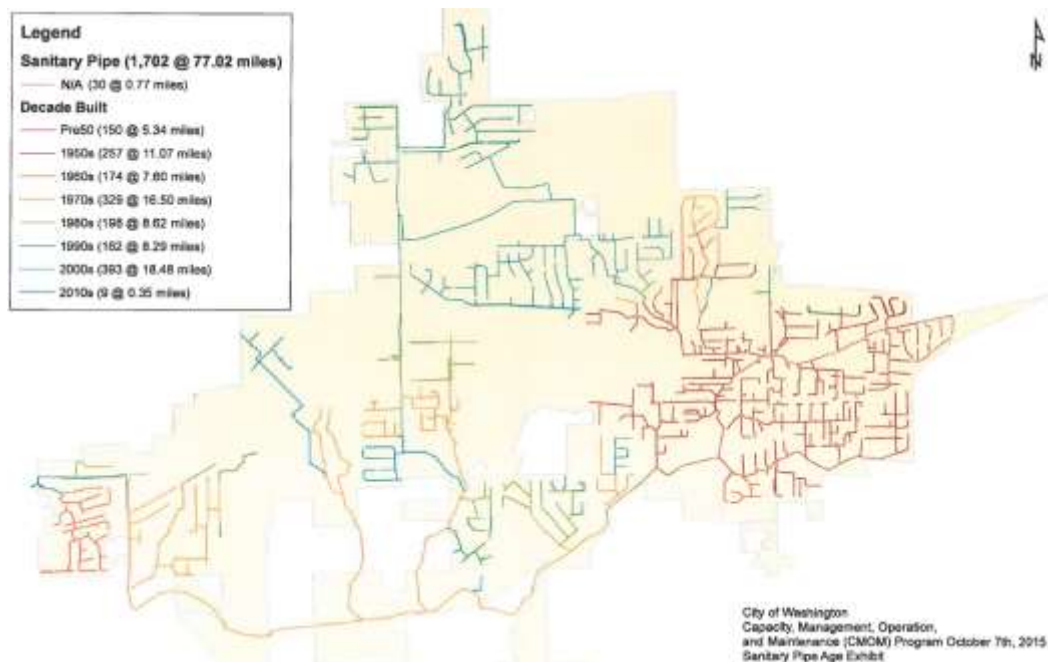
This was later separated in the 1980s to meet the requirements of the Clean Water Act. The general age of some of the original system warrants replacement or lining rehabilitation.
