**CITY OF WASHINGTON, ILLINOIS**  
**Public Works Committee Communication**

**Agenda Item:** Draft Capital Improvement Plan

## Capital Improvement Plan

Years 2020 to 2025

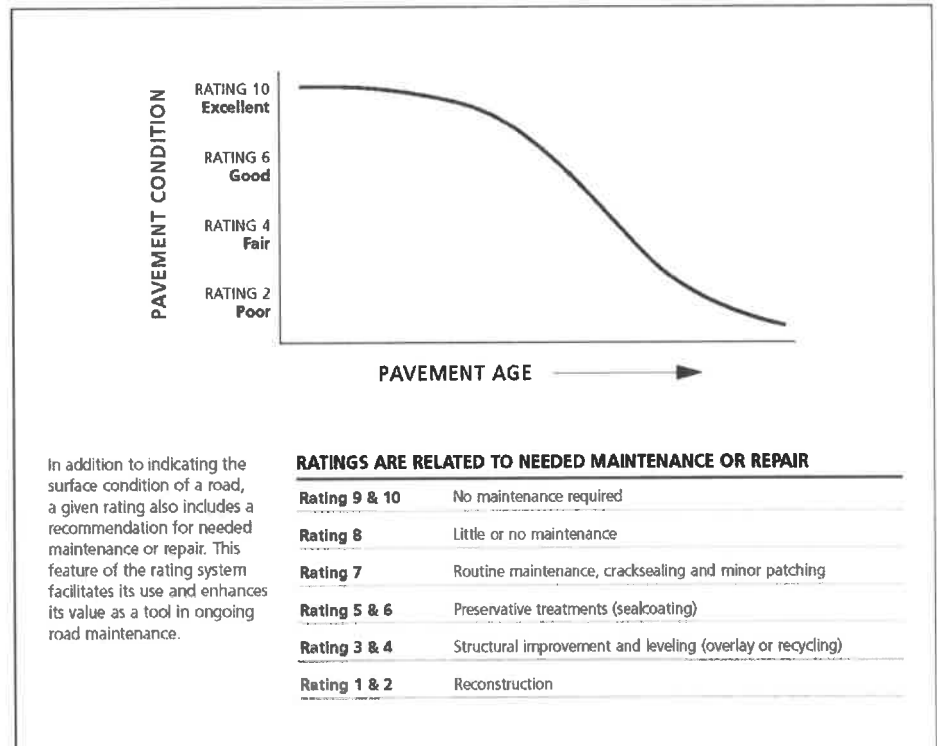
This graph and table are from the “PASER Manual for Asphalt Roads,” published by the Wisconsin Transportation Information Center. The PASER Manual provides guidelines for conducting the ratings as well as treatment recommendations based on the rating. Routine maintenance and preservation treatments are the recommended course of action for pavements rated in the 5 to 7 range. Pavements rated less than 5 typically require an asphalt overlay and reconstruction when the condition has completely deteriorated.

The good news is that only 2% of Washington streets have a rating less than 5. The 2017 data also rated 89% of Washington streets in the 5 to 7 range in 2017. If the rating data is believed to be a fair representation of pavement condition three years ago, we conclude that Washington has maintained the pavement in an acceptable condition. The future challenge is to adequately fund and execute pavement maintenance programs each year and apply the appropriate treatments based on actual pavement conditions.
