# City of Washington, Illinois

## Capital Improvement Plan

Years 2020 to 2025

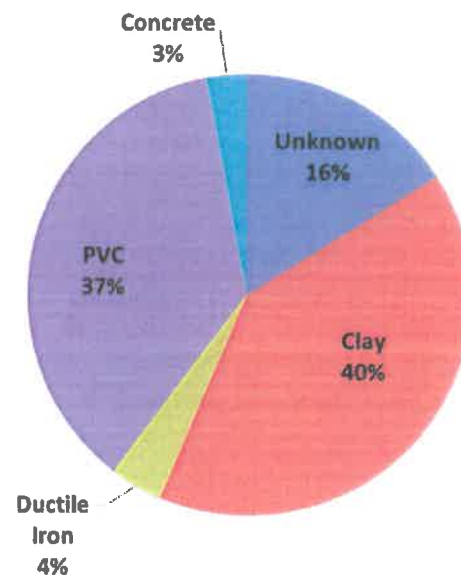
**SEWER COLLECTION SYSTEM MATERIAL**

Pipe materials along with sewer age within the collection system have a significant impact on the life expectancy or the level of maintenance required for a sewer segment. Collection and documentation of past sewer customer service calls can also be used a good indicator of the LOS for a sewer segment. Numerous calls for roots or blockage within a single area can help a municipality begin to schedule preventative cleaning/root cutting or prioritize a repair in that area.

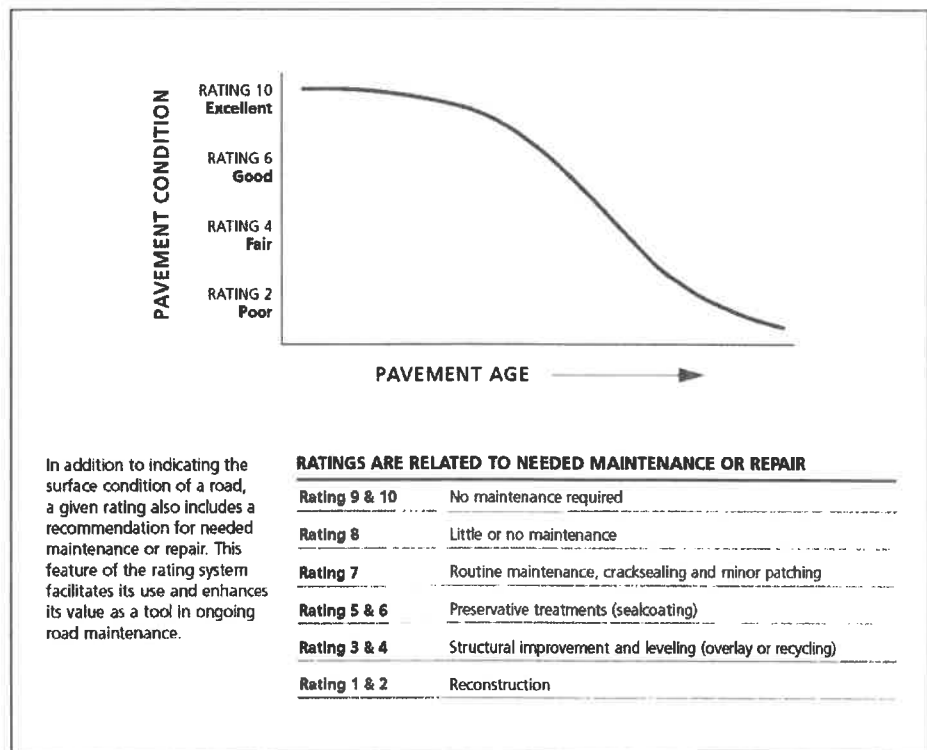
This graph and table are from the “PASER Manual for Asphalt Roads,” published by the Wisconsin Transportation Information Center. The PASER Manual provides guidelines for conducting the ratings as well as treatment recommendations based on the rating. Routine maintenance and preservation treatments are the recommended course of action for pavements rated in the 5 to 7 range. Pavements rated less than 5 typically require an asphalt overlay and reconstruction when the condition has completely deteriorated.

The good news is that only 2% of Washington streets have a rating less than 5. The 2017 data also rated 89% of Washington streets in the 5 to 7 range in 2017. If the rating data is believed to be a fair representation of pavement condition three years ago, we conclude that Washington has maintained the pavement in an acceptable condition. The future challenge is to adequately fund and execute pavement maintenance programs each year and apply the appropriate treatments based on actual pavement conditions.
