CITY OF WASHINGTON, ILLINOIS

Agenda Item: Draft Capital Improvement Plan

Capital Improvement Plan

Years 2020 to 2025

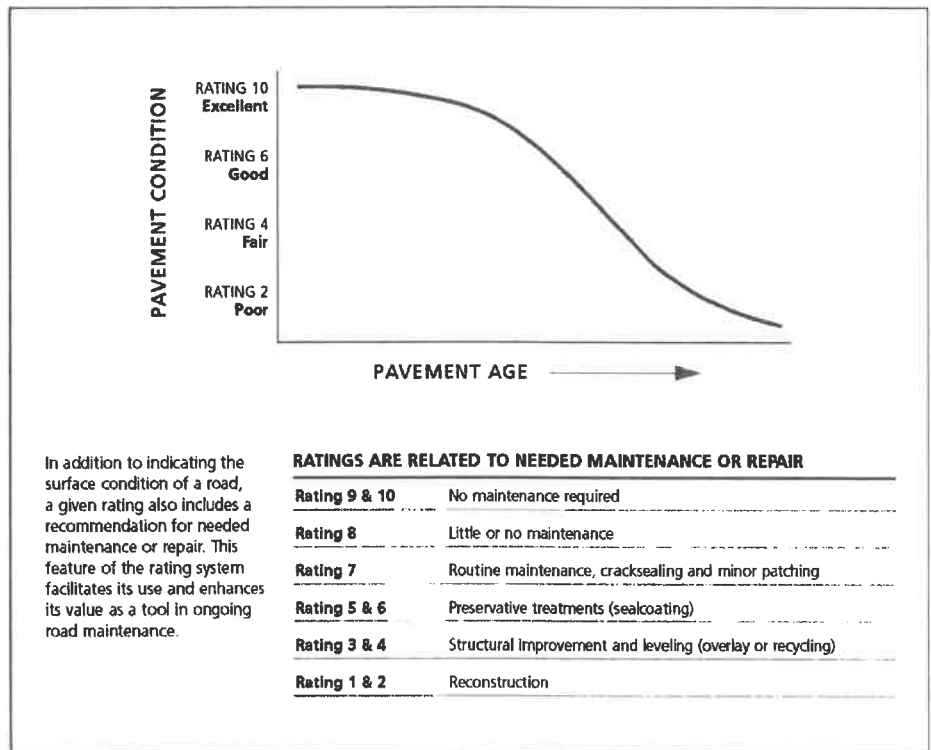
This graph and table are from the “PASER Manual for Asphalt Roads,” published by the Wisconsin Transportation Information Center. The PASER Manual provides guidelines for conducting the ratings as well as treatment recommendations based on the rating. Routine maintenance and preservation treatments are the recommended course of action for pavements rated in the 5 to 7 range. Pavements rated less than 5 typically require an asphalt overlay and reconstruction when the condition has completely deteriorated.

The good news is that only 2% of Washington streets have a rating less than 5. The 2017 data also rated 89% of Washington streets in the 5 to 7 range in 2017. If the rating data is believed to be a fair representation of pavement condition three years ago, we conclude that Washington has maintained the pavement in an acceptable condition. The future challenge is to adequately fund and execute pavement maintenance programs each year and apply the appropriate treatments based on actual pavement conditions.
